**City of Kingston  
Wastewater Collection System  
2025 ANNUAL REPORT**

**Environmental Compliance Approval Number: 018-W601  
Wastewater Collection System Owner: City of Kingston  
Wastewater Collection System Classification: Class III**

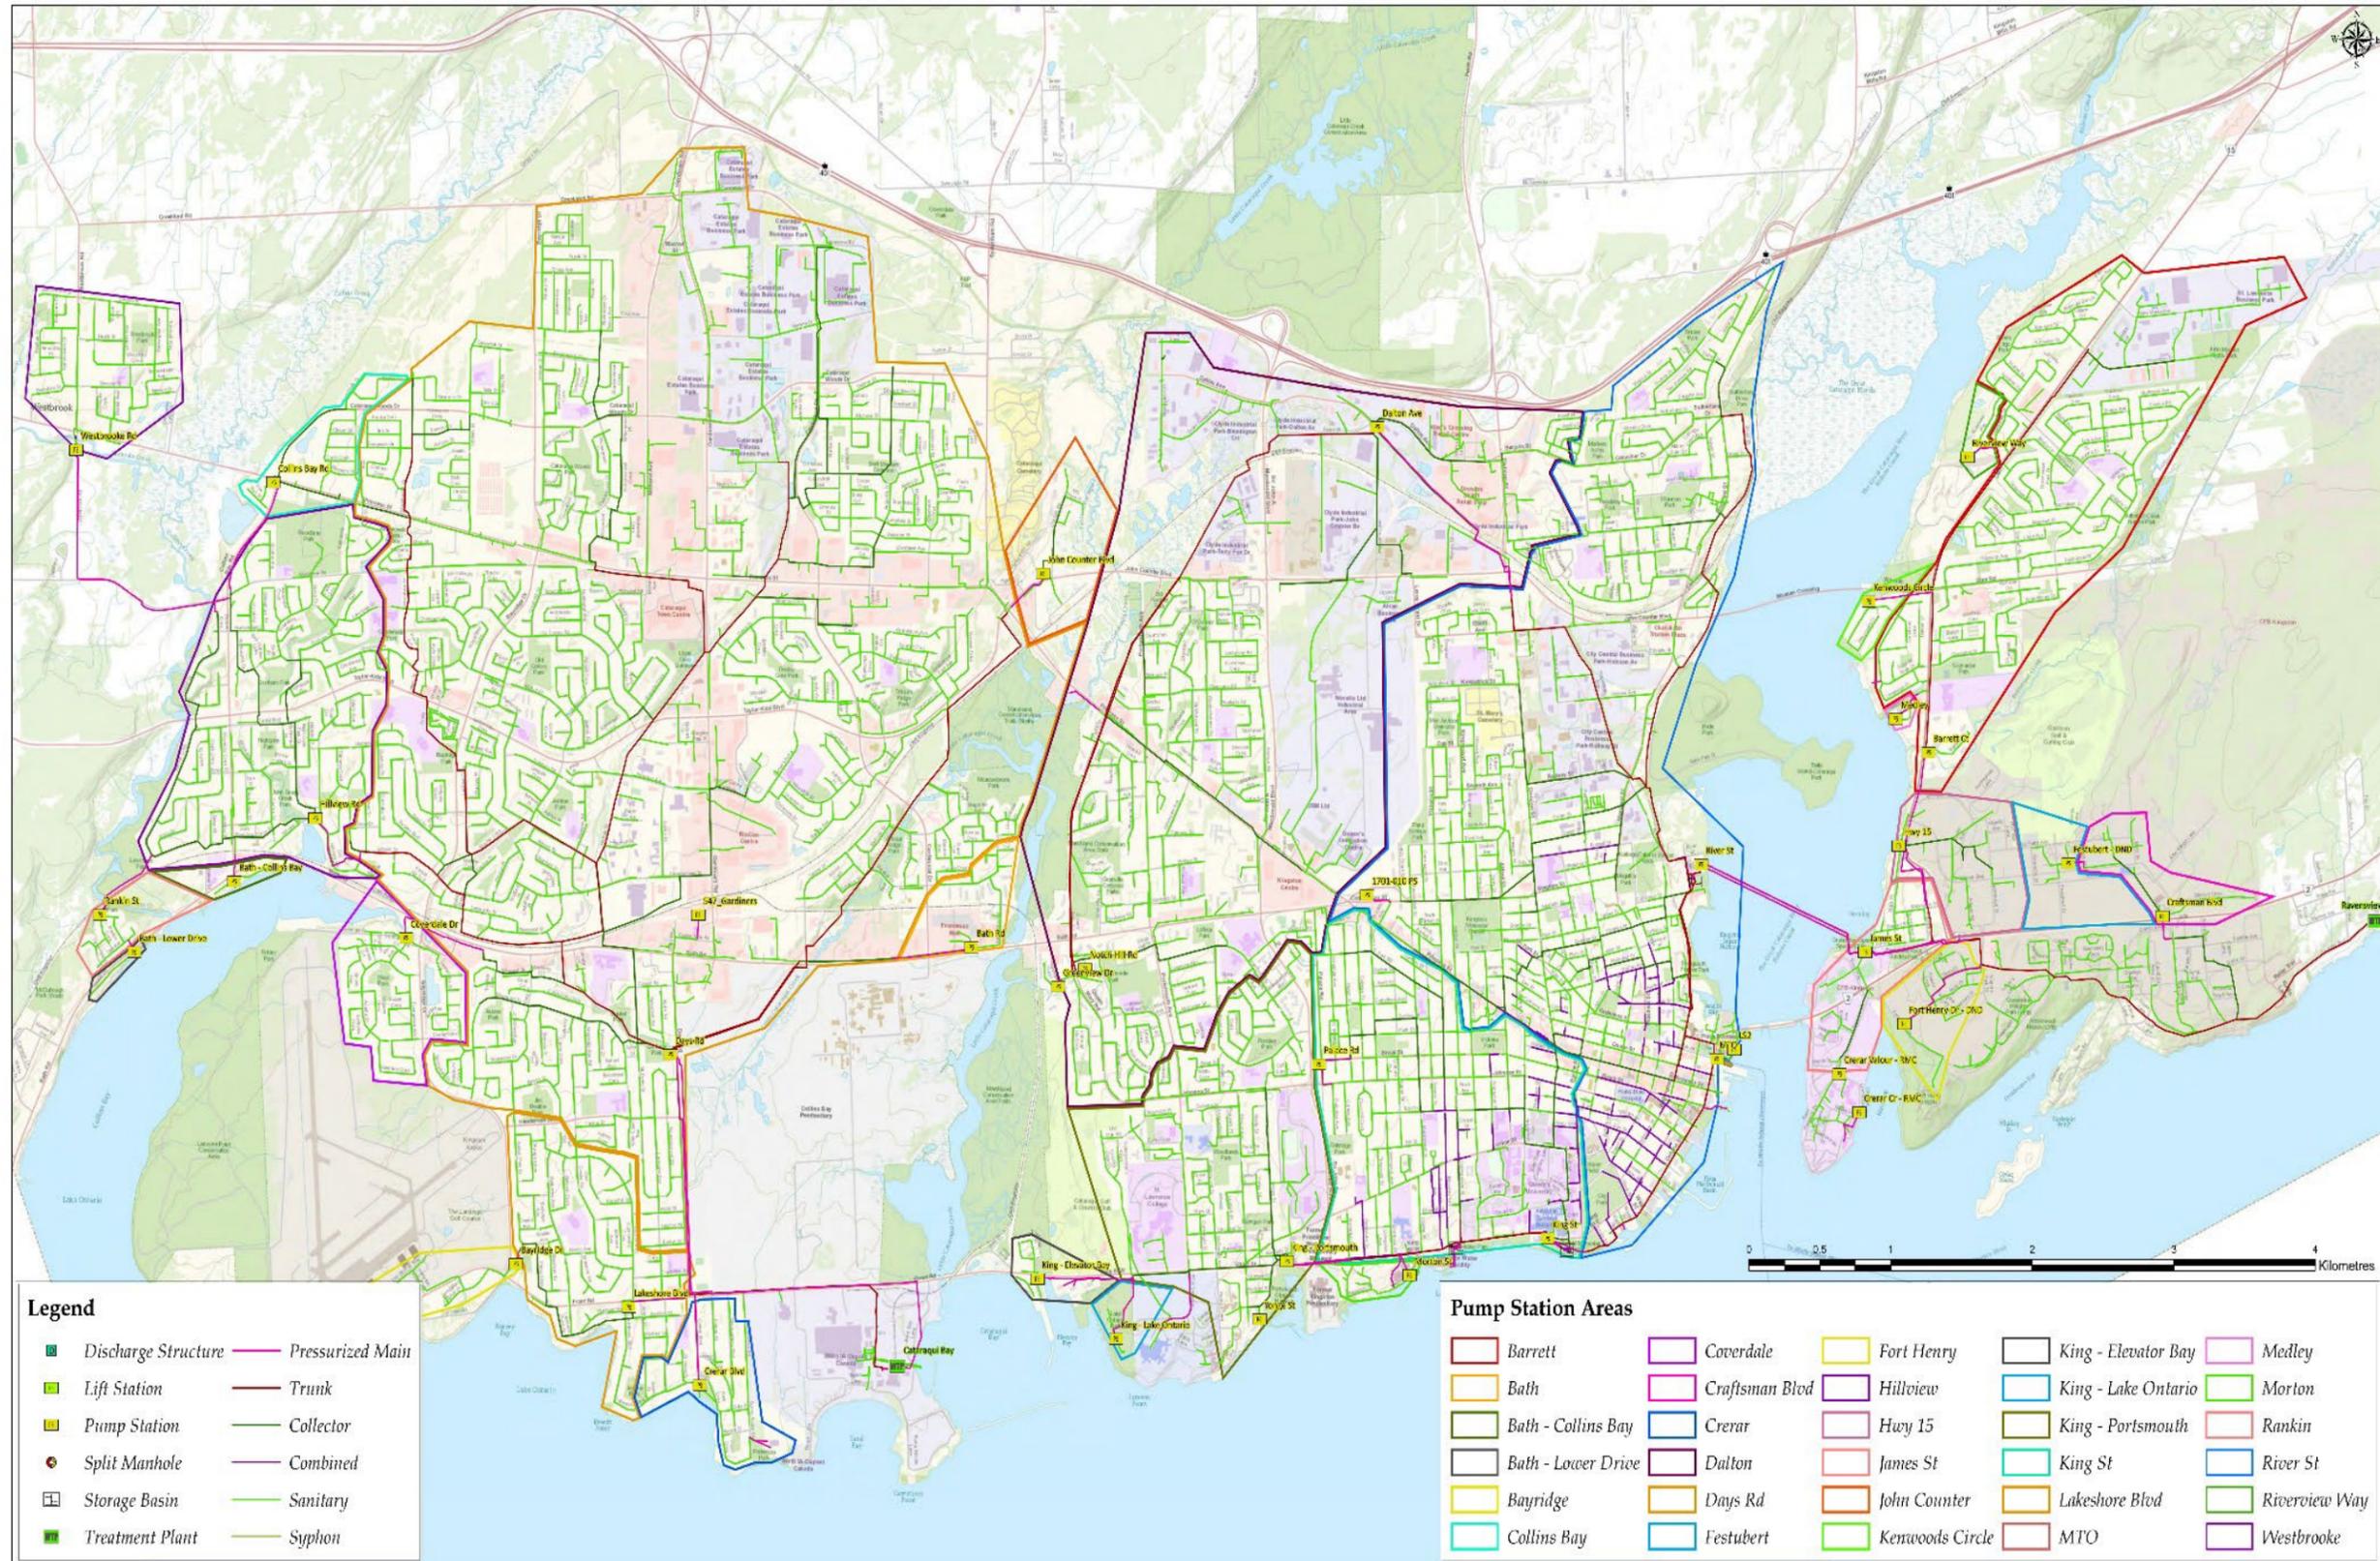
Figure 1 – City of Kingston Collection System Major Infrastructure

The City of Kingston Wastewater Collection System collects and transmits sewage to one of three WPCPs, depending on the pump station area. The collection system consists of 474 km of gravity sewers (including 42.8 km of trunk sewers, 50.7 km of collector sewers and 381.0 km of local sewers) and includes 18 km of combined sewers but excludes the approximately 38,384 active service laterals to the property line. The collection system comprises of 30 sewage Pumping Stations (PS), three Combined Sewer Overflow (CSO) tanks, six combined sewage retention tanks, and 29.0 km of forcemains. All flow is discharged into one of three Water Pollution Control Plants: Ravensview, Cataraqui Bay, and Cana.

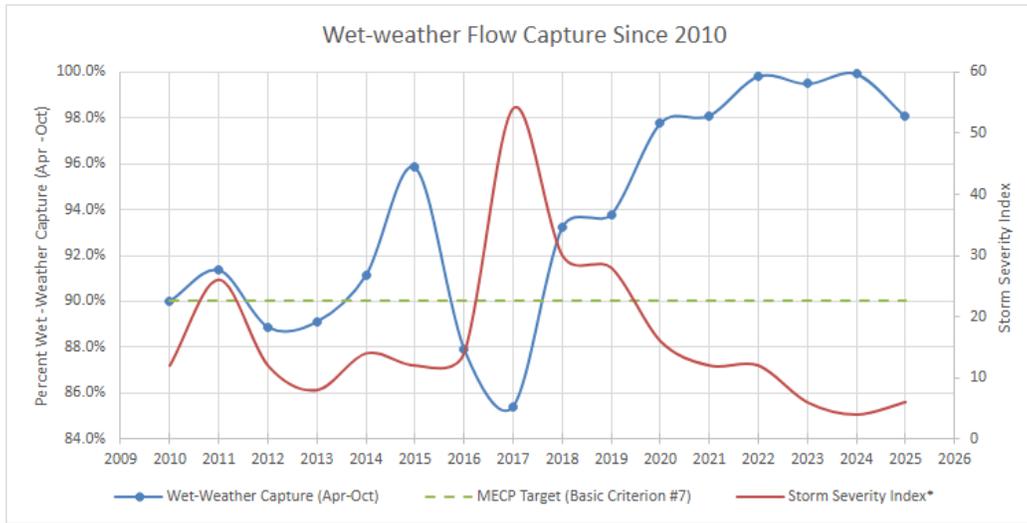
Figure 2 – Wet-Weather Flow Capture

The rainfall events in 2025 were more severe than in 2024, however less frequent, as seen in Figure 4 below. The wet weather flow capture rate is calculated by Utilities Kingston each year, and data going back to 2010 is shown in Figure 2 – Wet-weather Flow Capture. In 2017, Utilities Kingston released a real-time overflow map that displays overflow locations and lets you know if an overflow has occurred within the past 48 hours.
